APPENDIX BB
DEFENSE

DEFENSE

SUMMARY AND ANALYSIS OF RESULTS

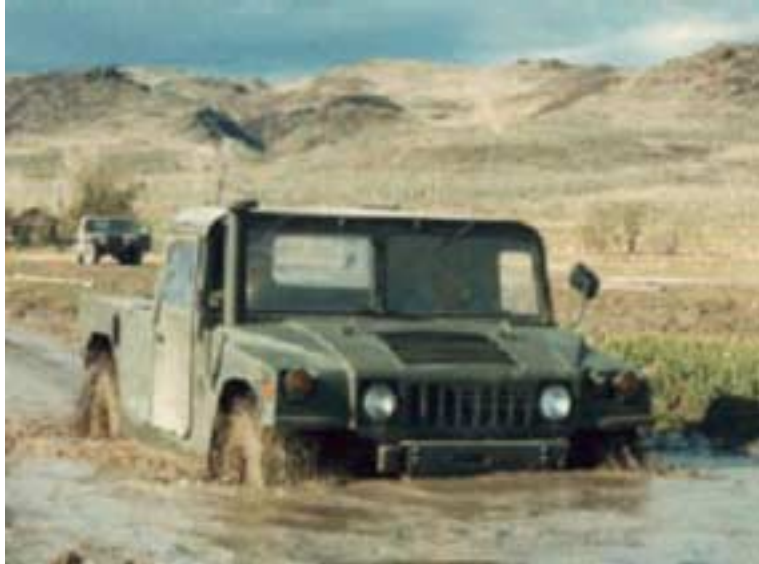
Figure 1. High-mobility multipurpose wheeled vehicle.

Generally, little attention is given to corrosion and corrosion control of Army vehicles. In fact, corrosion on these vehicles is allowed to occur until it affects their load-carrying capacity. Moreover, little has been done to incorporate corrosion protection and control in the design and manufacturing of Army vehicles. For example, none of the medium tactical vehicles has galvanized steel in the body. The high-mobility multipurpose wheeled vehicle (HMMWV) (see figure 1) is known to have several corrosion control shortcomings that result in very high corrosion maintenance costs.^(2,4) In designing the HMMWV, several corrosion control features that are now common in commercial vehicles have not been applied.⁽²⁾ One of the most glaring faults with the HMMWV is that the frame is built of ordinary 1010 steel and that no galvanizing or other corrosion protection is applied. A further problem with the frame is that holes are drilled into the sides of the frame with no drain holes in the bottom. This allows water and dirt to enter and stand inside the frame. Other problems include the use of 1010 carbon steel for components such as fasteners, handles, and brackets, as well as the use of dissimilar metal couples, such as aluminum frames bolted to the steel frames. These and other omissions of corrosion control have led to costly maintenance and repair. During an Inspector General’s Audit, various areas prone to corrosion were identified⁽⁴⁾ (refer to Case Study 1). The significant shortcomings identified by this audit included:

- use of 1010 carbon steel without galvanizing or any protective coating,
- presence of many galvanic couples and the use of more than 2,800 rivets that may act as possible locations for corrosion,
- use of painting procedures that are not state-of-the-art, and
- use of paint that provides little corrosion protection, such as the chemical agent-resistant coatings that deteriorate rapidly in the presence of a corrosive environment.

A problem throughout the vehicle is that 1010 carbon steel is used for many of the components, such as fasteners, handles, and brackets, as well as the frame. These parts have corroded on almost every HMMWV in service, leading to extensive repairs and maintenance. During the Inspector General's Audit, an examination was performed on 275 vehicles, showing multiple areas of corrosion. The results of this survey are presented in table 4, summarizing the major vehicle parts that the auditors inspected and found to be corroded. Most of these corrosion problems could have been eliminated using galvanizing and high-quality coatings. Other problems could have been avoided using polymers and other alternate materials. Care must be taken, however, in selecting these materials. For example, the hood of the HMMWV is made out of a type of polymer called sheet molding compound. The hoods have not had any corrosion problems, but they have often cracked (due to soldiers jumping on them while performing their duties) because of the poor elastic properties of the polymer.

Several different metals were used on the HMMWV, leading to dissimilar or galvanic corrosion. Much of the body of the HMMWV is made out of aircraft grades of aluminum, while the frame and doors are made of 1010 carbon steel. The entire vehicle is secured with more than 2,800 rivets and while this design affords the HMMWV a high strength-to-weight ratio, each of the rivets is a preferential site for corrosion.

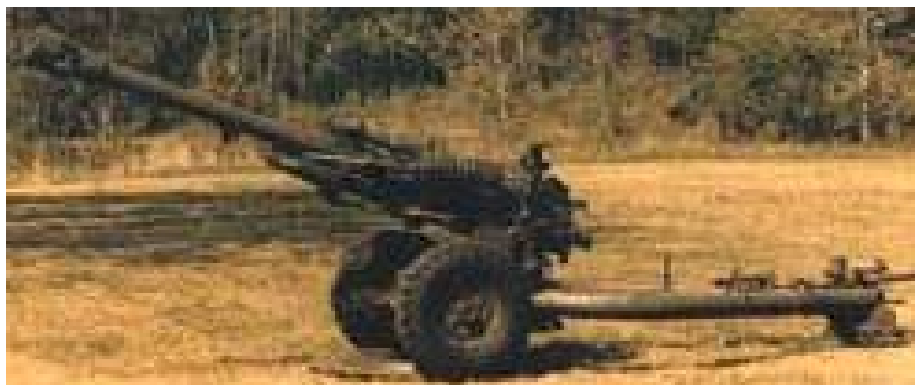
Figure 2. M119 105-mm towed howitzer.

Other significant contributors to corrosion costs in the Army are the howitzer firing platforms.⁽³⁾ The M119 is a 105-mm towed howitzer of British design (see figure 2). Procurement of the M119 started in the late 1980s and was completed in 1996, with a total of approximately 500. In early 1997, severe corrosion was detected on the platform. An investigation by the Army indicated several deficiencies that lead to severe corrosion, including various dissimilar metal contacts resulting in galvanic corrosion and areas on the platform where water could collect. The design of the howitzer platform was such that it needed to be replaced at a cost of \$18,000 each; therefore, the total cost to remedy the corrosion problem is estimated to be approximately \$9 million.

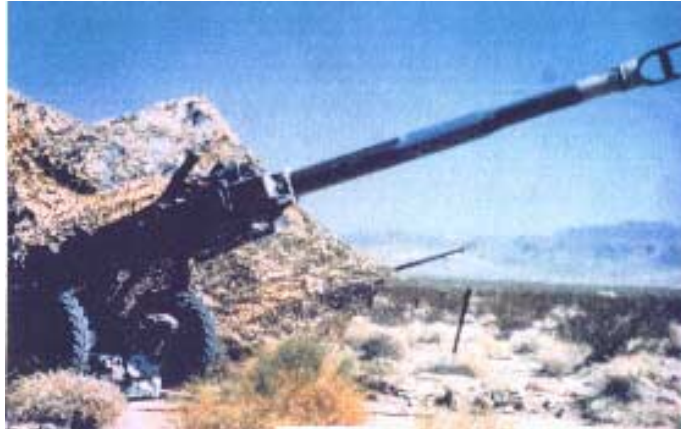
Figure 3. M198 towed howitzer.

A second howitzer corrosion problem is experienced with the towed M198 howitzer of which 1,800 are in service (see figure 3). In order to maintain system readiness, an annual expenditure of \$5,300 for parts replacement is required for each M198. The total annual maintenance cost for just corrosion-related parts replacement is estimated at \$10 million (1,800 x \$5,300). Figure 4 shows an attempt to avoid corrosion in an M198 howitzer frame by drilling a drain hole; however, by not having the drain hole at the lowest point, water can still collect inside the frame.

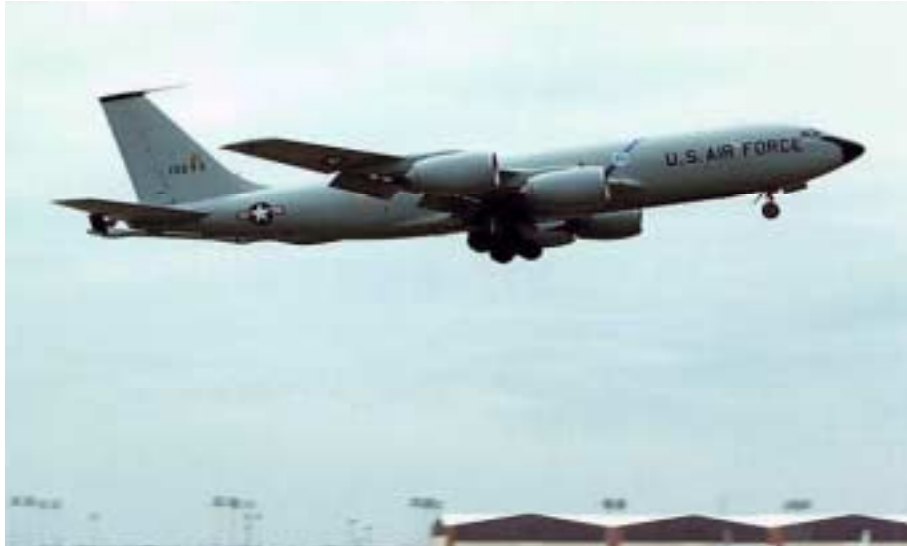
Figure 5. KC-135 tanker aircraft.

One of the most significant results was the effect of aging on weapon systems costs. Each of the oldest fleets of aircraft is a high-dollar driver where the difference in costs between these fleets is primarily a reflection of the difference in size and difference in age. Together, these fleets consume more than half of the total corrosion maintenance costs expended by the Air Force. It is anticipated that these corrosion maintenance costs will increase due to continued aging of the fleet. For example, the KC-135 fleet (see figure 5), which was built between 1955 and 1963, is, despite its age, the backbone of the Air Force's tanker fleet. The KC-135 was never meant to handle its

mission for this long and was therefore not constructed with corrosion prevention as a primary concern. Moreover, since no funds are available for replacement tankers, it was decided to operate the fleet until the year 2040. Without extensive corrosion maintenance, structural degradation due to corrosion will limit the KC-135 life to less than the year 2040. Because of the decision to extend the service life of the KC-135 well beyond its corrosion design life, corrosion maintenance expenditures have increased from an average of \$176,327 per aircraft in 1990 to \$341,464 per aircraft in 1997, which is a 94 percent increase. Cost forecasts by the Air Force predict that during the first decade of 2000, the cost of airframe depot maintenance will increase by a factor of two to three. After this period, the costs are expected to level off if all critical components that are subject to corrosion damage are repaired or replaced. Case Study 2 will discuss the KC-135 in more detail.

The KC-135 Stratotanker is a strategic air refueling tanker built by the Boeing Company, which can also be used as a cargo carrier or troop transport. The first KC-135 entered the Air Force fleet in 1957 and the last one was delivered in 1965. Currently, about 550 of the 732 tankers built remain in service. As a result of a decreasing DOD budget, there have been insufficient funds available to procure KC-135 replacement aircraft. Due to insufficient funding, the current KC-135 fleet has been projected to remain in service until 2040. With the average KC-135 tankers being more than 40 years of age, they will be more than 80 years old in 2040 and will have been in service for more than four times their original design service life. Generally, the structural life of both commercial and military aircraft is based on flight hours and number of fatigue cycles. In general, the life of aircraft is

fatigue-limited, and corrosion is never considered to be a life-limiting factor. The minimum KC-135 structural fatigue life-limited components are the fuselage and the upper wing skin at 66,000 to 70,000 hours, while the actual fleet hours are only 15,000. Since the KC-135 utilization averaged only 300 to 400 flight hours per aircraft per year, it appears that the fleet can easily remain in service until 2040.

However, severe corrosion has been experienced on the aluminum alloy components of the KC-135 aircraft. This corrosion is the result of low utilization, where the majority of the time is spent on the ground being exposed to the corrosive atmospheric environments. In the 1950s, the KC-135 was never designed and constructed with corrosion prevention as a primary concern. The original structural alloys were aluminum alloys 2024-T3 and -T4, and 7075-T6 and 7178-T6, which are all susceptible to corrosion and stress corrosion cracking. The original construction was without any sealant in the lap joints and fuselage skins that had spot-welded doublers attached to them. Finally, the upper wing skins, which are made of the highly corrosion-susceptible aluminum alloy 7178, were attached with high-strength steel fasteners, causing dissimilar metal corrosion in certain areas.

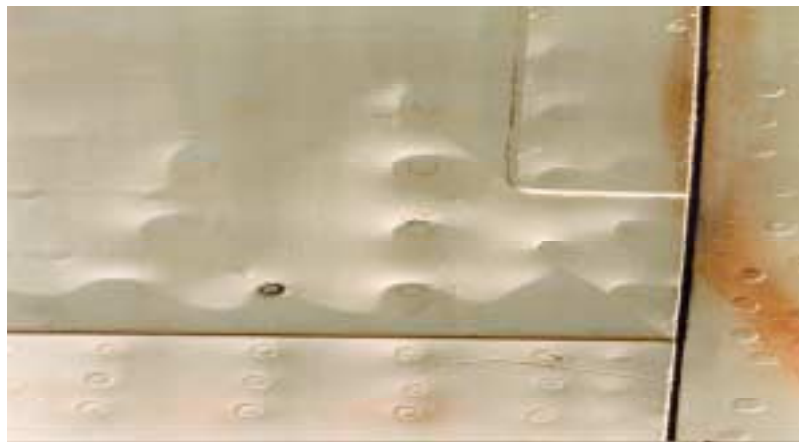
Figure 7. Photograph and schematic cross-section of the pillowing phenomenon resulting from lap joint corrosion.

A particularly severe problem is corrosion of the fuselage lap joints, where the voluminous corrosion products at the contact or faying surfaces of the lap joint cause deformation of the skin.⁽¹¹⁻¹²⁾ Figure 7 shows a photograph and a schematic cross-section of this so-called pillowing phenomenon. Because of the resulting stress fatigue and stress corrosion, cracks can nucleate near the fastener holes, jeopardizing the structural integrity of the fuselage. Other corrosion problems on the KC-135 aircraft include dissimilar metal corrosion and lap joint corrosion on the 7178 upper wing skin, lap joint corrosion on the 7075-T6 fuselage crown section, and stress corrosion cracking of the 7075-T6 forged frame sections.
