APPENDIX D
HIGHWAY BRIDGES

HIGHWAY BRIDGES

Corrosion Control and Prevention

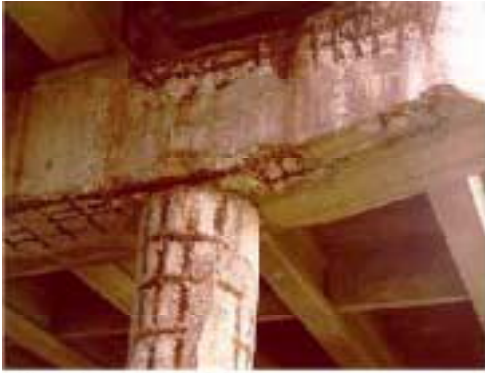
Corroded bridge column

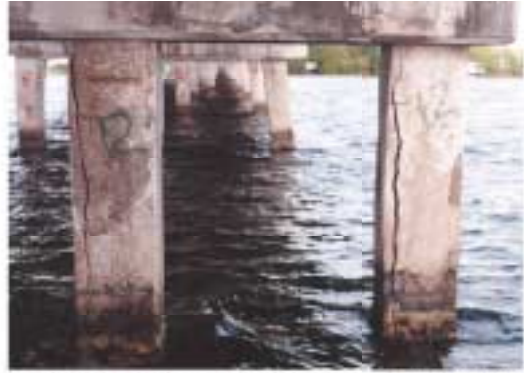
Cracking and spalling of piers in marine environment

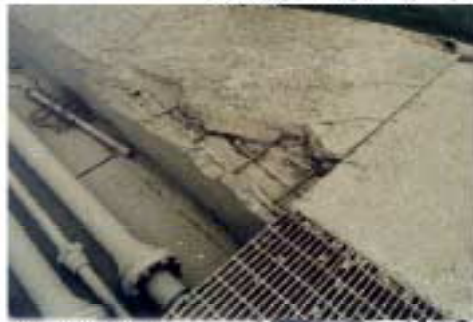
Damaged concrete, exposing rebar

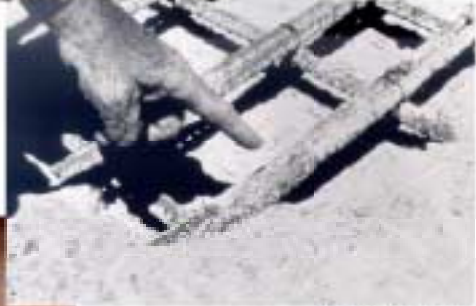
Corroded rebar

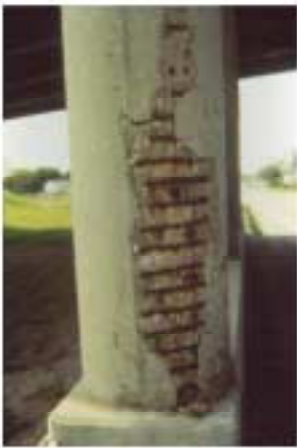
Corroded concrete column

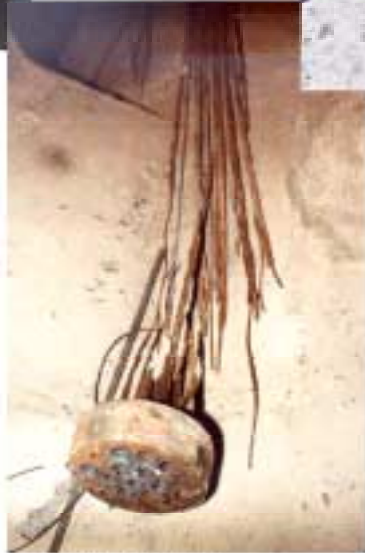
Failed strands

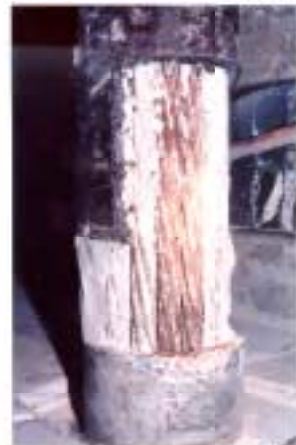
Corrosion in the free length of tendon

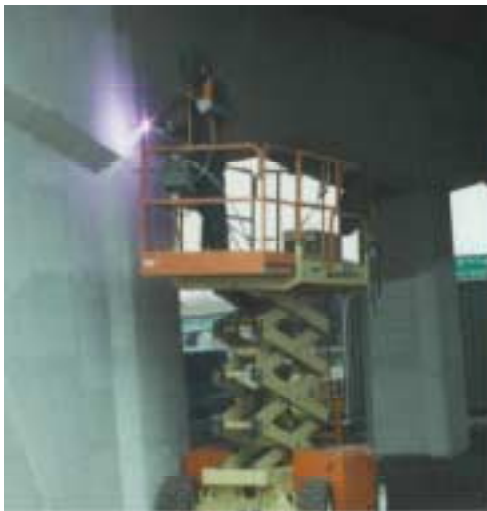
Application of thermal spray metal coating as sacrificial anode system on bridge pier

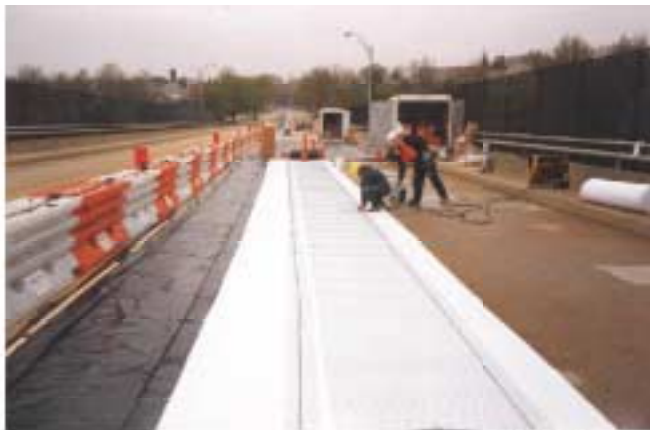
Deck installation of titanium mesh and synthetic felt anode system on bridge deck.

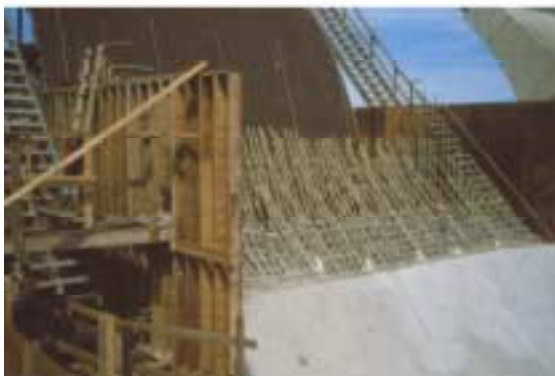
ALSEA bridge, Oregon, with epoxy-coated rebar substructure

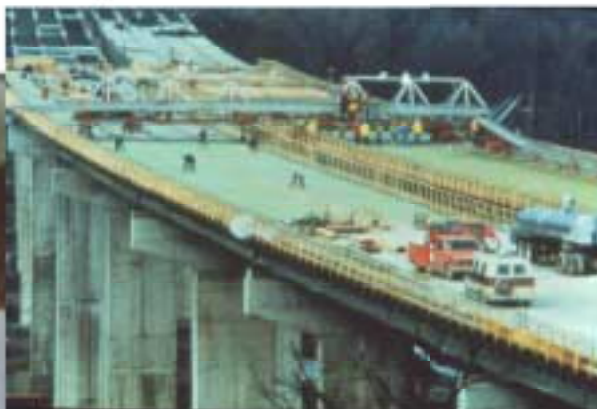
Epoxy-coated rebar construction on deck

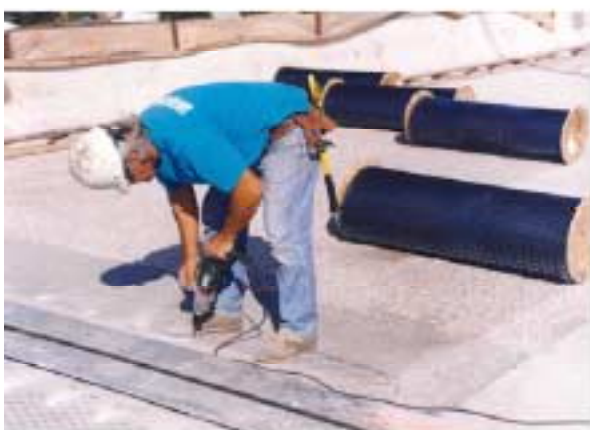
Installation of titanium mesh impressed-current anode system on bridge deck

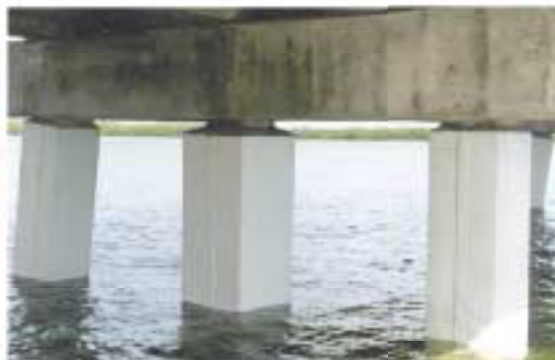
Sacrificial CP applied to pier columns in marine environment

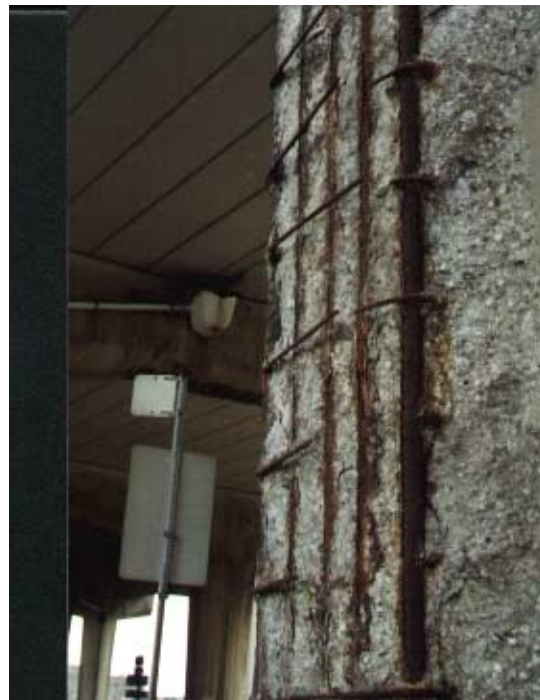
Figure 2. Example of deteriorating bridge element.

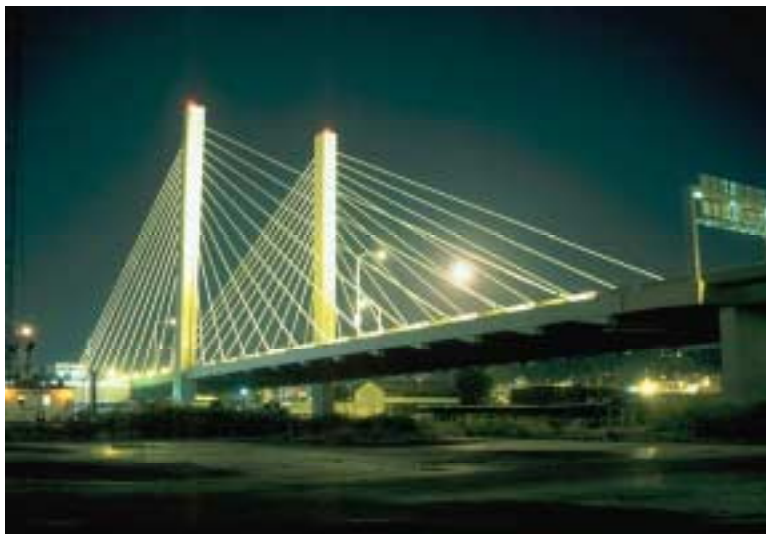
Figure 6. SR509 bridge in Tacoma, WA (cable-stayed).

A more recent design of cable bridges is the so-called cable-stayed bridge (see figure 6). Presently, there are only 30 cable-stayed bridges in the United States. However, because the integrity of the cables is critical to the structural integrity of the entire bridge structure, and inspection of the cables is very difficult, the cable-stayed bridges are built with special considerations for corrosion protection.⁽⁹⁾

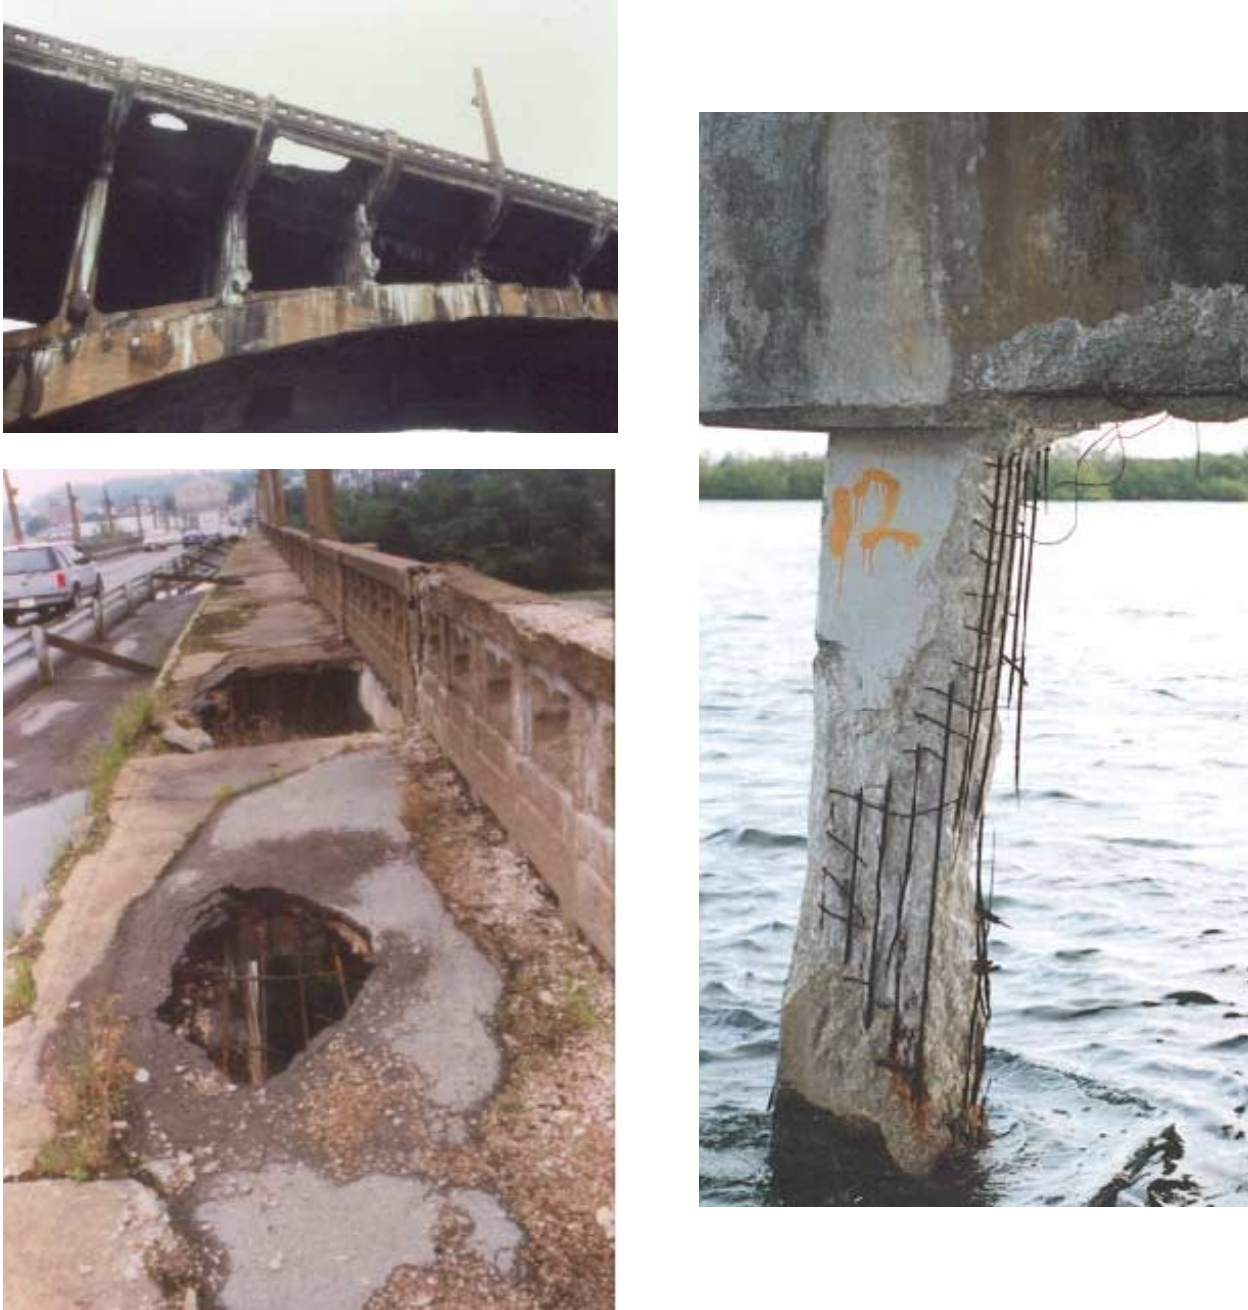
Figure 8. Examples of severe corrosion resulting in deficient bridges.

The annual cost of structurally deficient bridges (see figure 8) is estimated as the cost to replace these bridges over a 10-year period; it is calculated using a \$29.3 billion as a present value of the cost (see “Areas of Major Corrosion Impact” for calculation) at a 5 percent annual percentage rate (APR). Assuming annual payments for the replacement cost, the annual cost to replace structurally deficient bridges (both reinforced concrete and steel) over the next 10 years is \$3.79 billion per year. Recall that this value is for the current number of deficient bridges and does not account for the additional ones added to this number each year. Therefore, this cost is potentially greater than that given here.

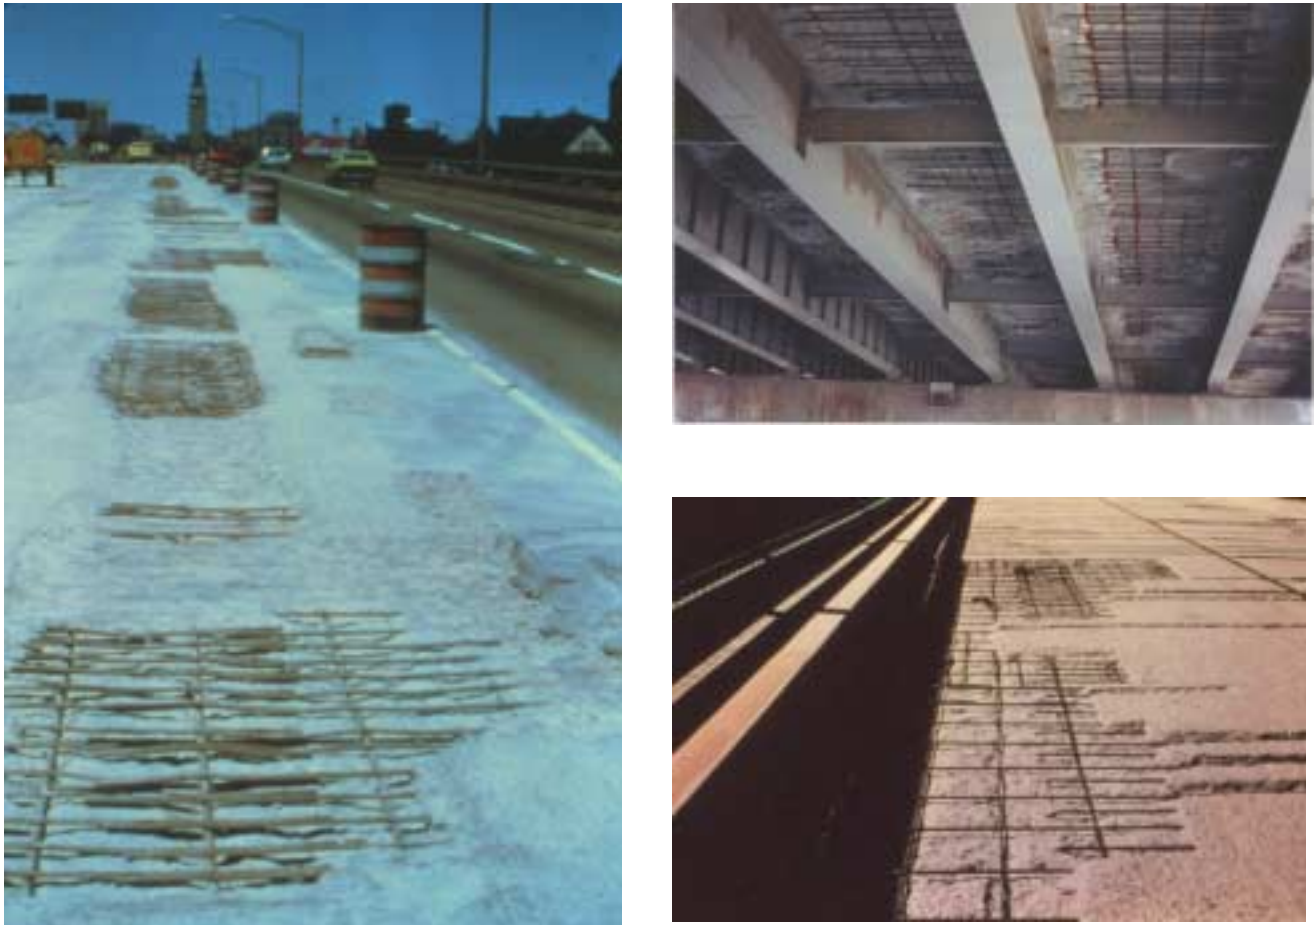
Figure 9. Examples of bridge deck corrosion.

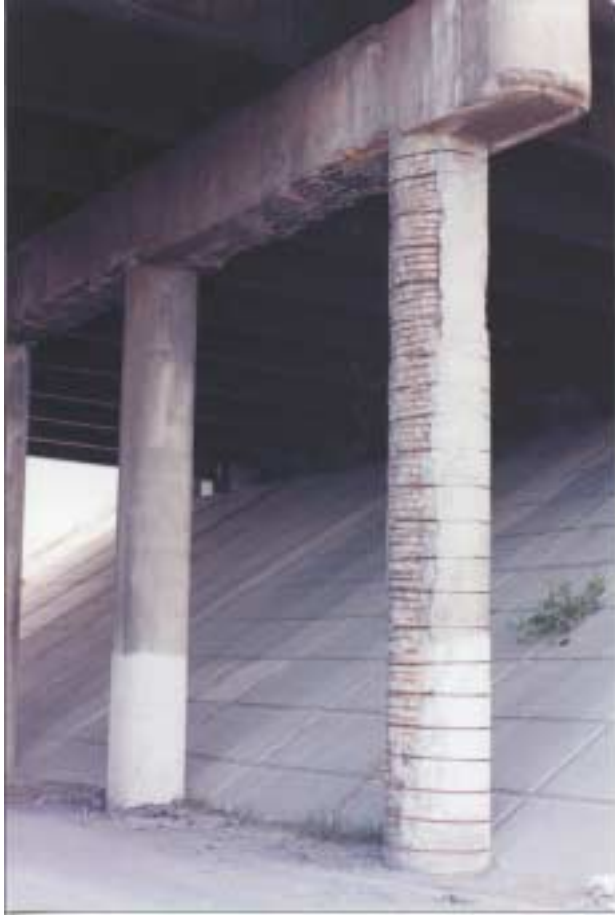
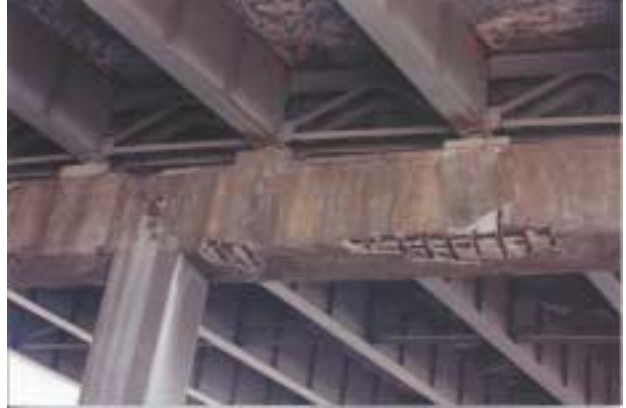
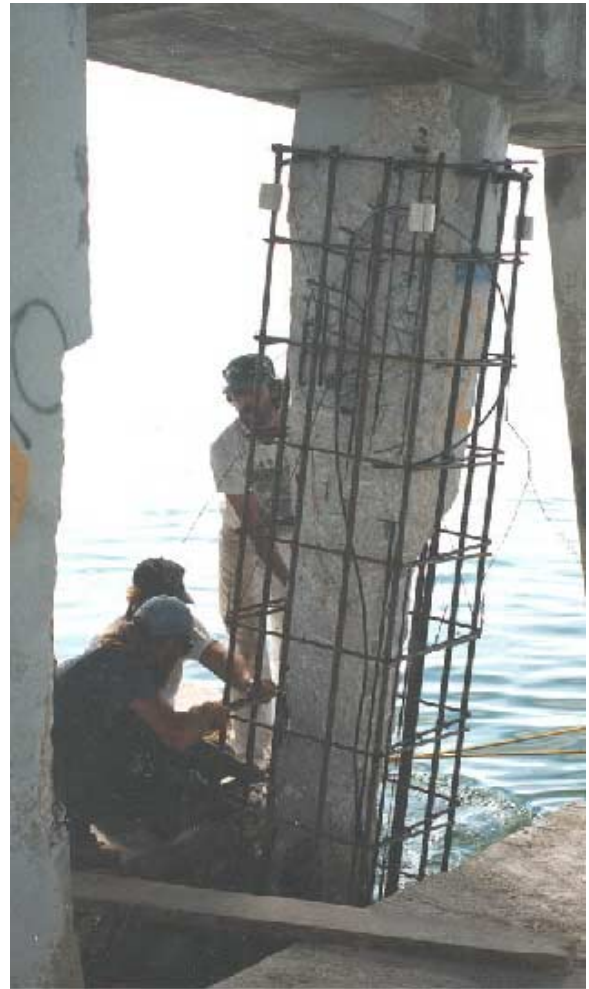
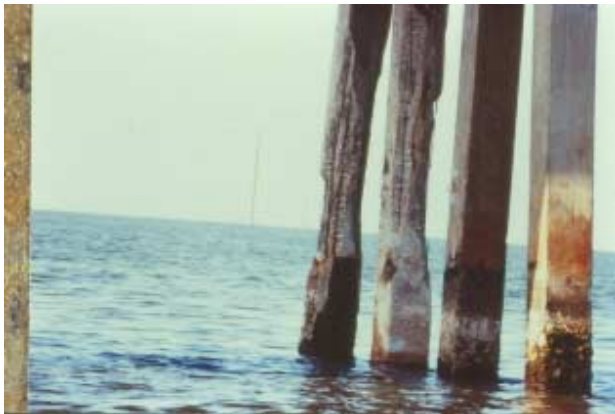
Figure 10. Examples of substructure corrosion.

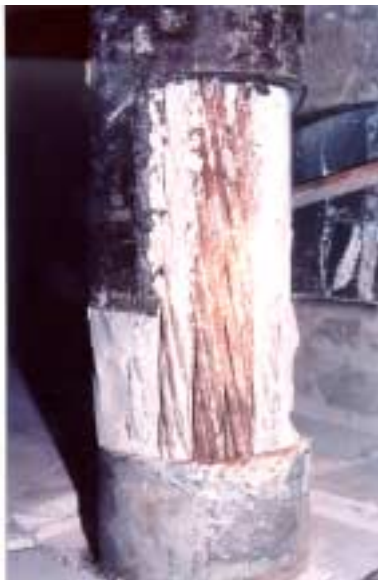
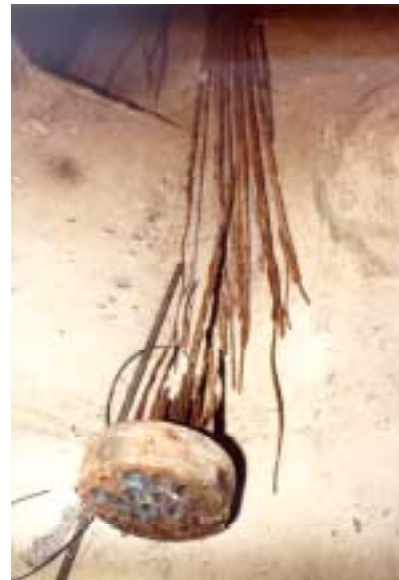
Figure 11. (a) corrosion in the free length of tendon, (b) failed strands.

During a 1999 routine inspection, it was noted that the pour-back concrete had spalled, exposing the wedge plate at the NW anchorage (middle tendon) at Expansion Joint No. 2 (Pier 9). Subsequent investigation revealed that each of the 19 strands making up that tendon had failed due to corrosion, thus rendering the tendon nonfunctional. The appearance of the failed strand is shown in figure 11. Following removal of the wedge plate and strands, the examination of the trumpet showed heavy corrosion on the upper-half of the trumpet with moderate pitting. The appearance indicated that the upper-half of the trumpet had never been in contact with grout, but instead that space had been occupied by bleed water. Although the heaviest corrosion on the strands was in the trumpet region, corrosion extended up approximately 1.5 m (5 ft) from the bulkhead. The likely cause of corrosion was determined to be due to bleed water being present at the time of construction, recharging of the environment within the void, and possibly aggravation by chlorides.

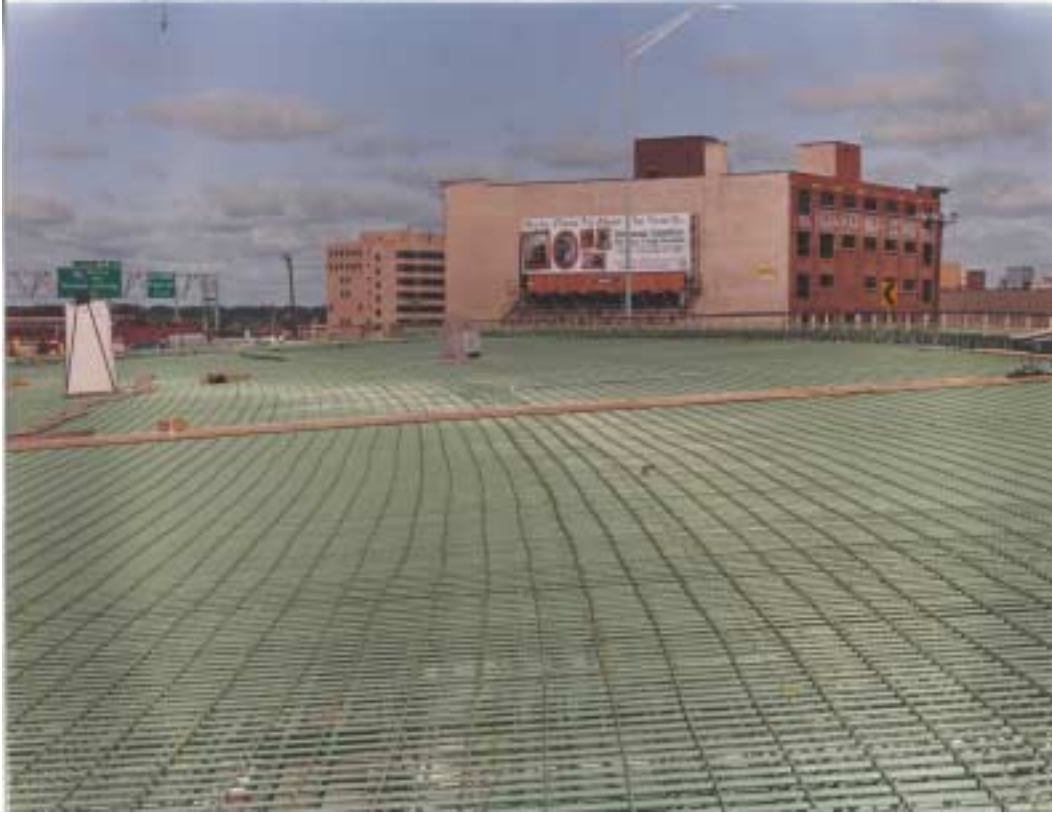
Figure 13. Epoxy-coated rebar deck construction.

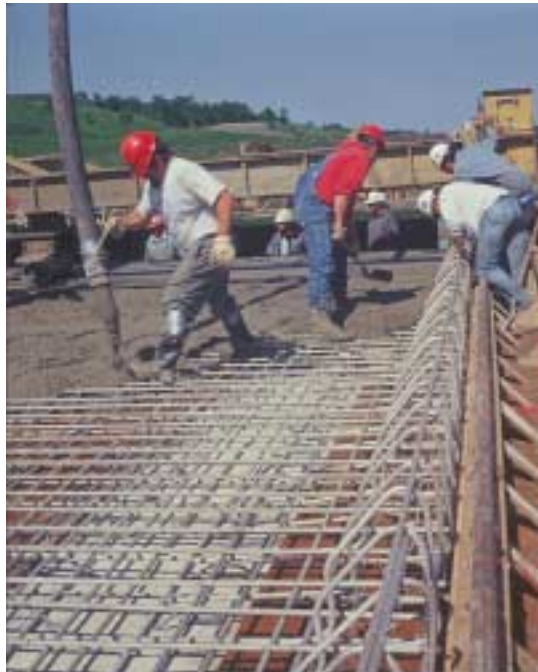
Figure 14. Stainless steel-clad rebar deck construction.

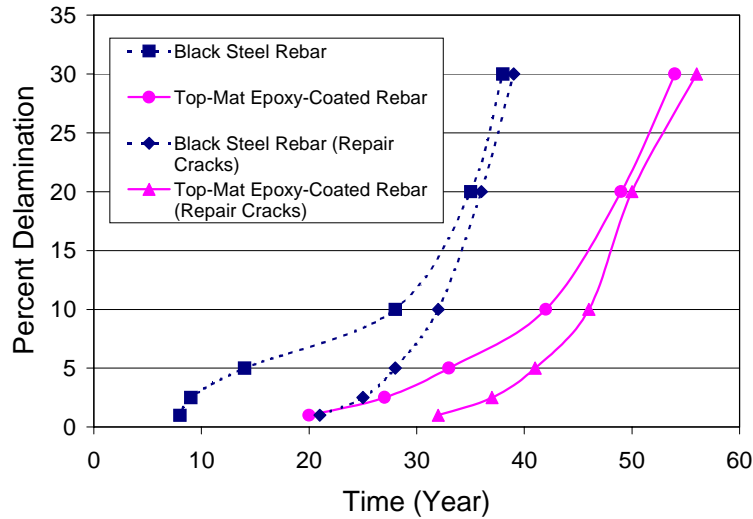
Figure 15. Deterioration models for the black steel rebar and top-mat epoxy-coated rebar deck.

The rate of deterioration with time is required to perform a life-cycle cost using the “information-based” maintenance practice described below. McDonald et al. published estimated times as a function of delamination for a black steel rebar deck and the top-mat epoxy-coated rebar deck (based on laboratory experiments), which is used as a foundation for the deterioration models (see figure 15).⁽¹⁸⁾ The deterioration models also consider the impact of repairing cracks in the concrete. Repairs to the cracks tend to significantly extend the time to delamination in the early life of the deck, but after 10 percent delamination, the effect becomes much less.

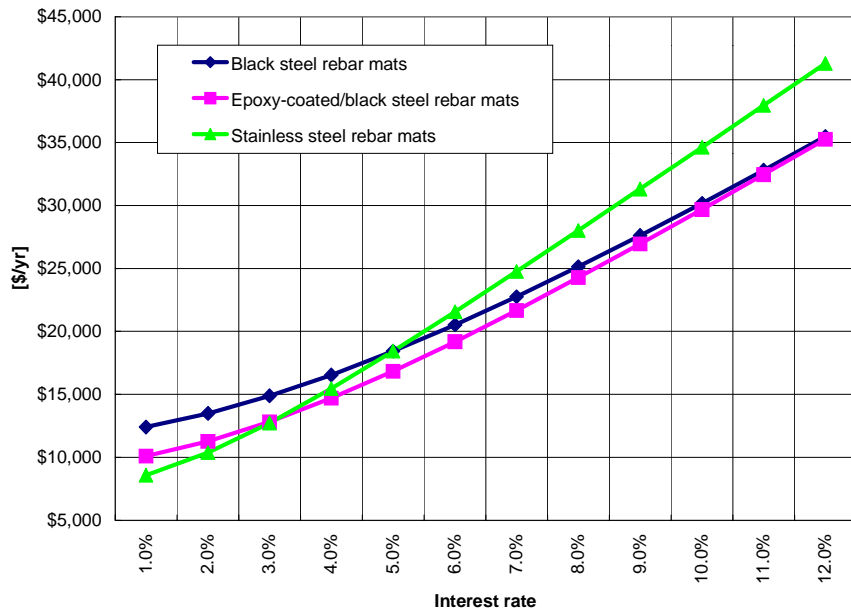
Figure 16. Effect of the interest rate on the annualized values for the “information-based with crack repair” scenario for the three bridge deck designs (no user cost).

Figure 16 shows the “information-based with crack repair” maintenance scenario applied to the three rebar design cases. The first observation is that annualized costs increase with increasing interest rates. At low interest rates (below 3 percent), the stainless steel rebar design (high initial capital cost) has the lowest annualized cost; while at higher interest rates, epoxy-coated rebar has the lowest costs. Although the epoxy-coated rebar design has a lower cost than black steel rebar design at all interest rates, as the interest rate increases, black steel rebar design costs approach those for the top-mat epoxy-coated rebar design. It is interesting to note that black steel rebar and its increased maintenance has a lower annualized cost than stainless steel rebar design at interest rates greater than 5 percent.

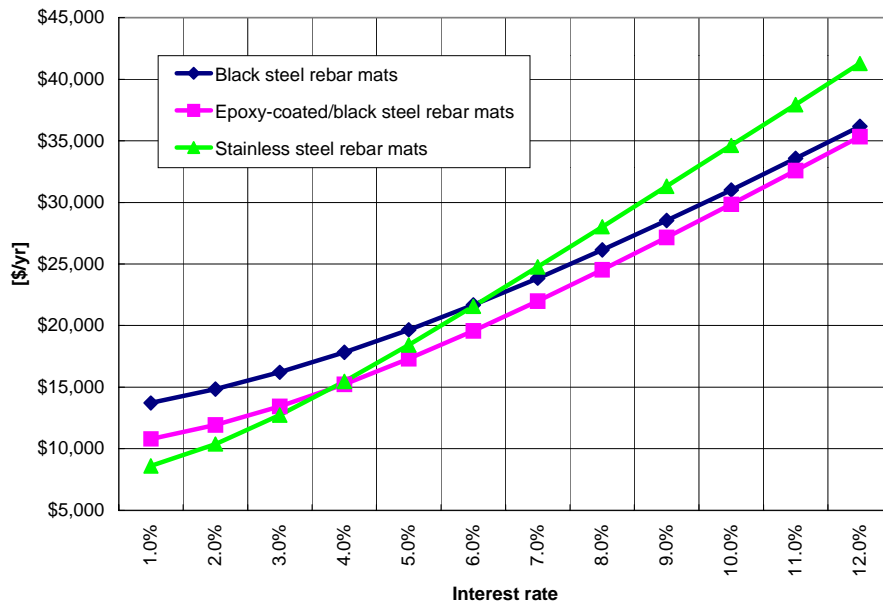
Figure 17. Effect of the interest rate on the annualized values for the “information-based, no crack repair” scenario for the three bridge deck designs (no user cost).

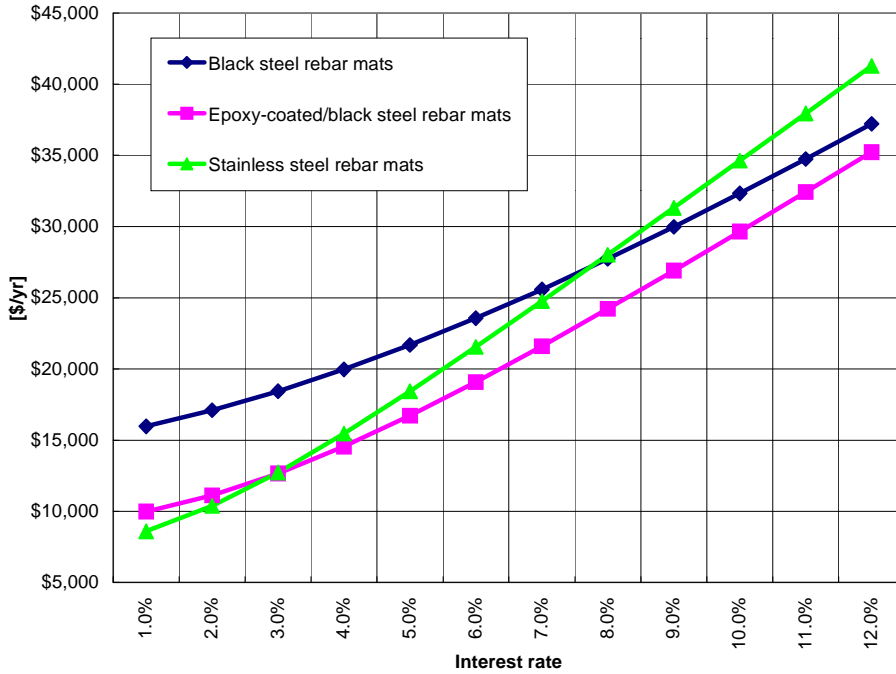
Figure 18. Effect of the interest rate on the annualized values for “experience-based” scenarios for the three bridge deck designs (no user cost).

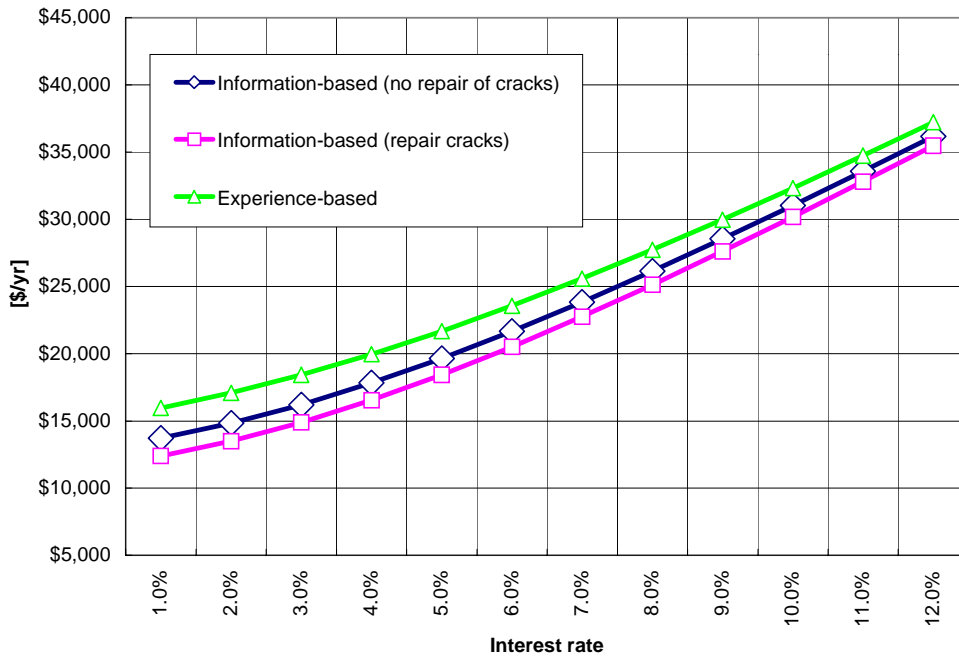
Figure 19. Effect of the interest rate on the annualized values for three corrosion maintenance scenarios and based on the black steel rebar design (no user cost).

Figure 19 shows that the more maintenance-intensive black steel rebar design was more sensitive to the maintenance scenario selected. The annualized cost decreased with the more aggressive maintenance schedule (the lowest annualized cost was achieved by the “information-based with crack repair” scenario and the “experience-based” scenario had the highest annualized cost). This observation suggests that regular inspection of the black steel rebar deck can lower cost through timely scheduling of the repairs.

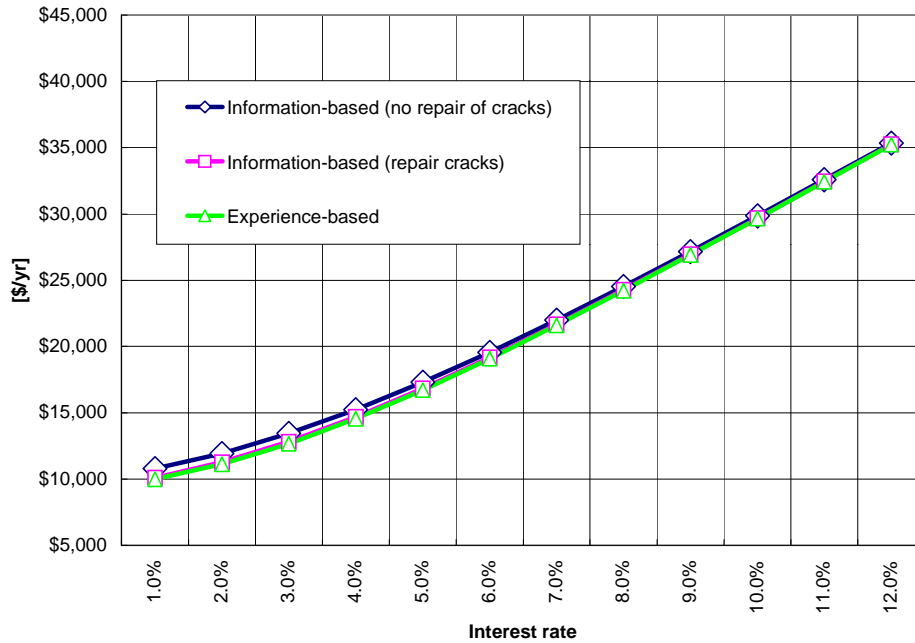
Figure 20. Effect of the interest rate on the annualized values for three corrosion maintenance scenarios and based on the top-mat epoxy-coated rebar design (no user cost).

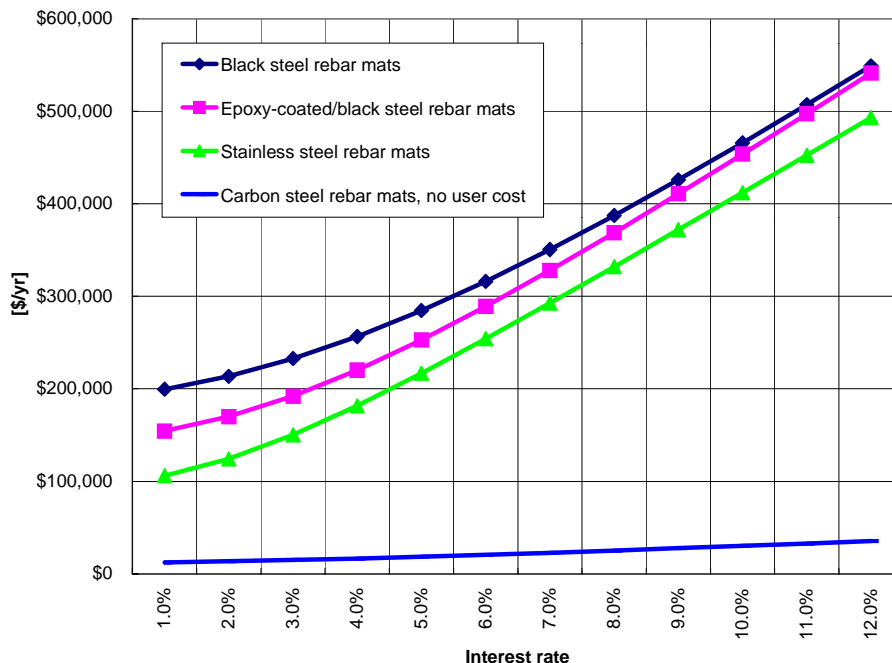
Figure 21. Effect of the interest rate on the annual values for “information-based with crack repair” maintenance scenario for the three deck designs (user cost included, no diversion).

Figure 21 shows that including the user cost in the analysis does not change the basic conclusions that lower interest rates favor high initial costs, while high interest rates favor high maintenance cost scenarios. For comparison, the cost for the black steel rebar design “with no user costs” is included in each figure. Including user costs increased the annualized cost of the bridge by a factor of 10 to 15.

Figures 21, 22, and 23 show the annualized costs, including the user cost, for the three maintenance scenarios: (1) information-based crack repair, (2) information-based no crack repair, and (3) experienced-based. The effect of the maintenance approach was similar to that described for the no user cost analysis, i.e., only the black steel rebar design was sensitive to the choice of maintenance scenario. The relationship between top-mat epoxy-coated rebar design and stainless steel rebar design remained the same for each maintenance scenario, i.e., the stainless steel rebar design is favored for all interest rates.

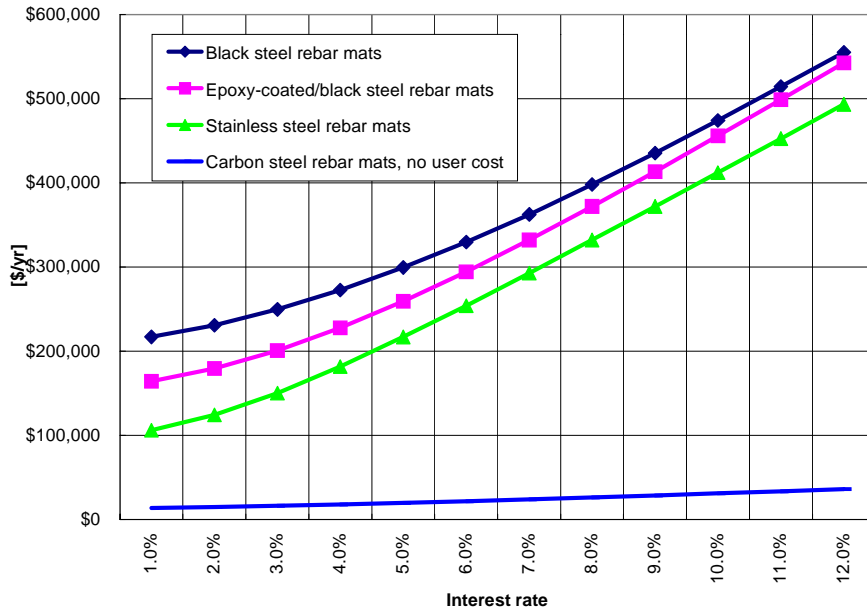
Figure 22. Effect of the interest rate on the annual values for “information-based with no crack repair” maintenance scenario for the three deck designs (user cost included, no diversion).

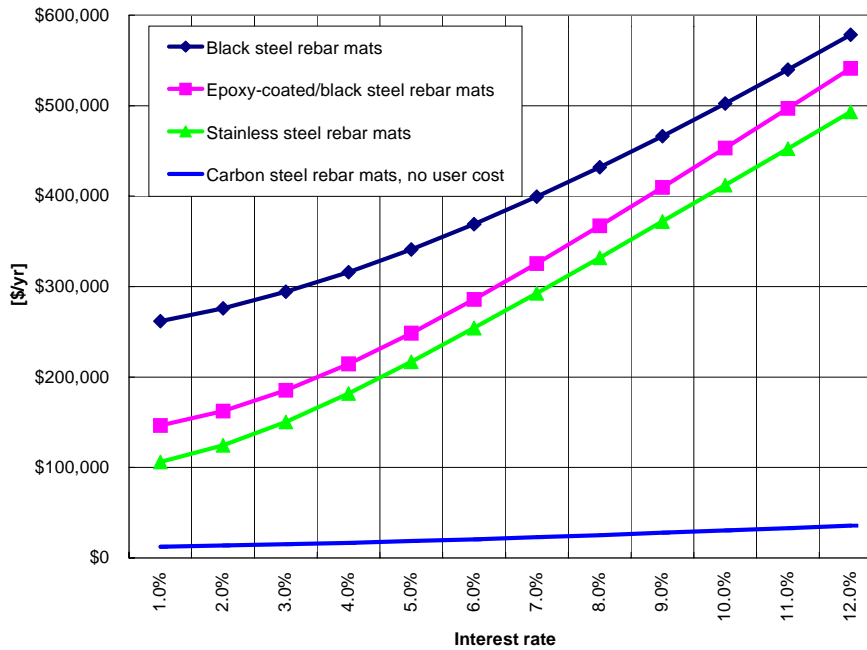
Figure 23. Effect of the interest rate on the annual values for “experience-based” maintenance scenario for the three deck designs (user cost included, no diversion).

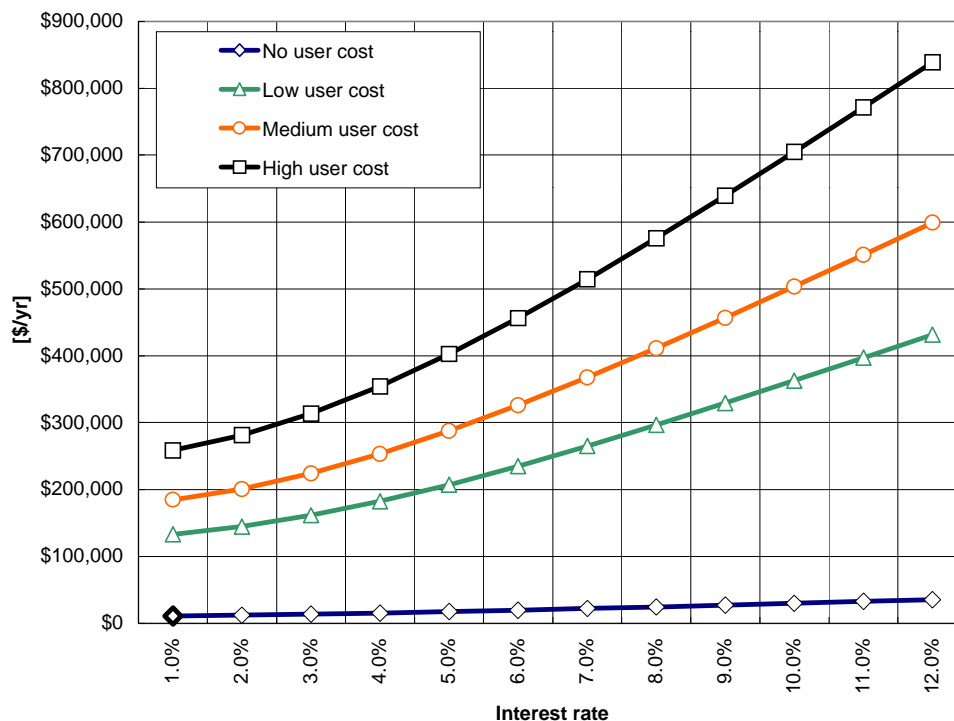
Figure 25. Effect of the interest rate on the annual values for the “information-based with crack repair” maintenance scenario for the epoxy-coated rebar mat design with three levels of user costs (with diversion).

Figure 25 shows the top-mat epoxy-coated rebar design annualized cost for the “information-based with crack repair” maintenance scenario with three different levels of user costs (with diversion) compared to that without user cost. A significant increase in annualized bridge cost occurs when the user costs increase. For example, at a 5 percent interest rate, the range of user cost presented in table 26 results in an increase in annualized cost of the bridge deck from \$16,800 with no user cost to \$205,000 at low user cost to \$400,000 at high user cost.
